## **ADRE® for Windows - instrumental in solving a complex vibration problem on a boiler feedwater pump**

*by Ibrahim Al-Ajmi  
Vibration Supervisor  
Operations  
Engineering Dept.*

*Saudi Consolidated  
Electric Company,  
Kingdom of Saudi Arabia*

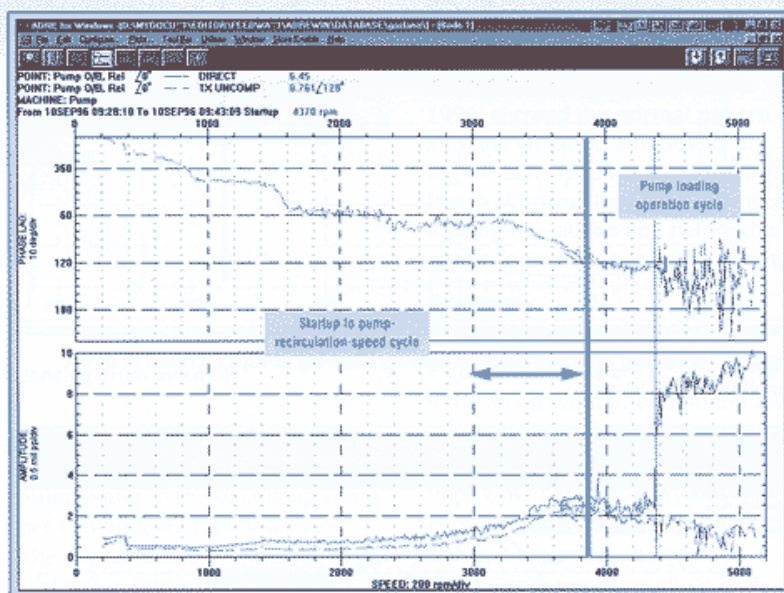
Figure 2. Bode plot of pump outboard bearing showing abrupt increase in direct amplitude at 4370 rpm.

The Bode plots (Figures 2 and 4) illustrate the abrupt increase in direct vibration amplitudes on the pump outboard and inboard bearings at 4370 rpm during pump loading. The half spectrum cascade plots (Figures 3 and 5), on the other hand, show subsynchronous peaks at 0.87X rpm, which were mainly responsible for the remarkable increase in vibration amplitudes at the pump bearings. Similar vibration signatures and patterns were also observed on the turbine bearings, but with lower amplitude levels. This vibration behavior was considered the result of the extremely high vibrations on the pump and was, therefore, not included in the analysis.

The Bode plot shown in Figure 2 indicates that the pump has a balance resonance frequency occurring at 3790 rpm. This is unusual in that most pumps, due to the hydraulic stiffening influence of the seals, typically have their balance resonance frequency above operating speed. The system stiffness of a pump is determined by the rotor geometry, seals, and bearings. If the stiffness properties of any of the elements is degraded or weakened, the resonance frequency will be lowered. It was noted by inspection that the rotating balance disk had a longitudinal

During the pump loading cycle, a subsynchronous vibration occurred at 0.87X. The pump speed at which this occurred was 4370 rpm. The source of the subsynchronous vibration is the excitation of the resonance frequency ( $4370 \times 0.87 = 3801$  cpm). As the pump speed was increased from 4370 to above 5000 rpm, the subsynchronous vibration remained at 0.87X. As the pump is loaded, additional stiffening occurs from internal seals and wear rings. This increases the resonance frequency and maintains the excitation at 0.87X.

An inspection of the pump internals revealed a longitudinal crack in the rotating balancing disc in the balancing drum assembly. The entire pump rotor assembly was replaced instead of just the balancing drum because of concern about the integrity of the other internal parts on the existing rotor.

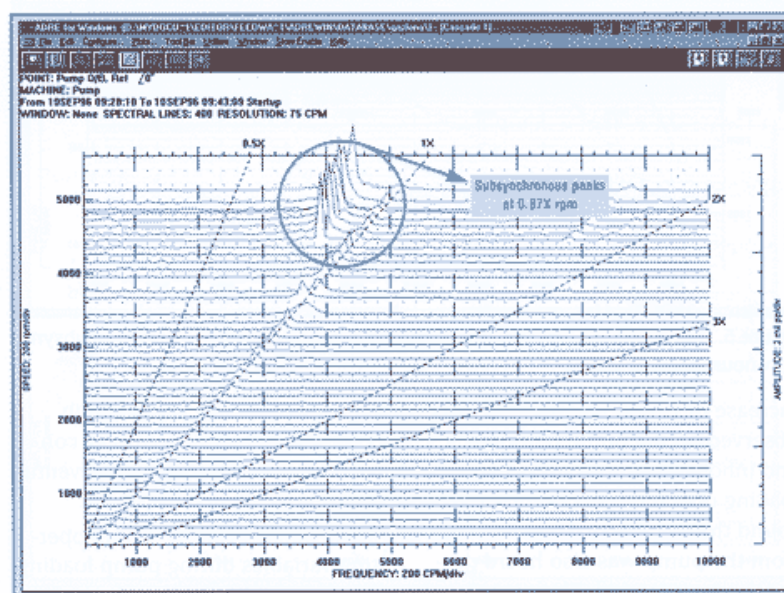
Figure 3. Half spectrum cascade plot of pump outboard bearing showing the sub-synchronous peaks at 0.87X.

The subsynchronous peaks in Figures 3 and 5 were first thought to be an oil whip phenomenon on the pump bearings. However, the machine uses tilting pad type bearings, which are normally not susceptible to oil whirl and oil whip induced vibrations. Besides, oil whip signatures normally manifest at less than 0.5X (2600 cpm in this case) and not at 0.87X (4370 cpm).

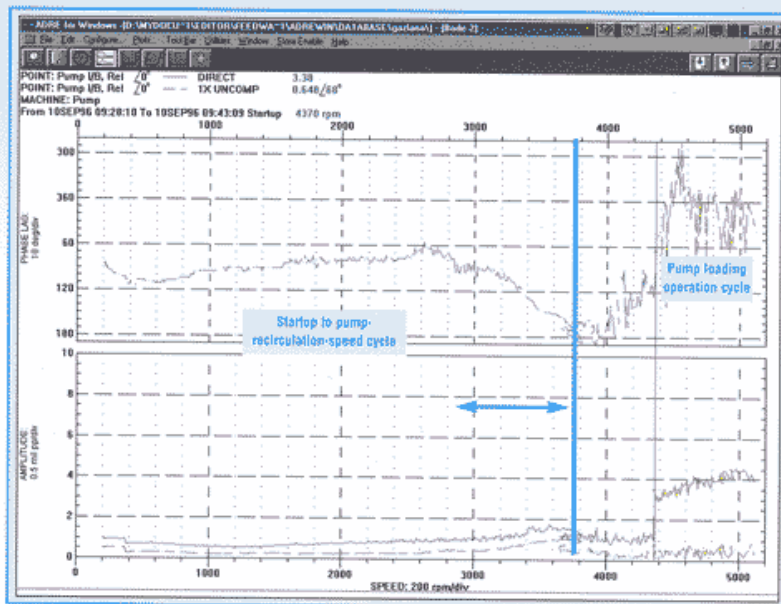
Figure 4. Bode plot of pump inboard bearing showing abrupt increase in direct amplitude at 4370 rpm.

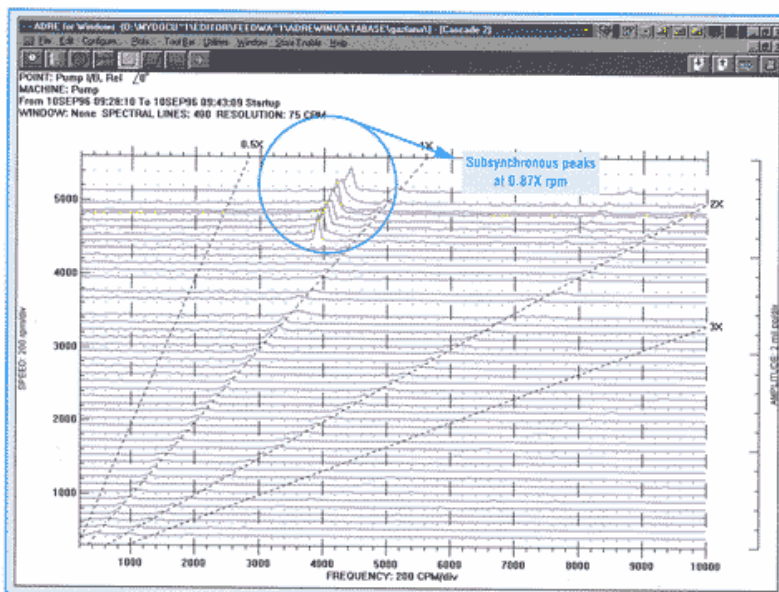
Figure 5. Half spectrum cascade plot of pump inboard bearing showing the subsynchronous peaks at 0.87X.

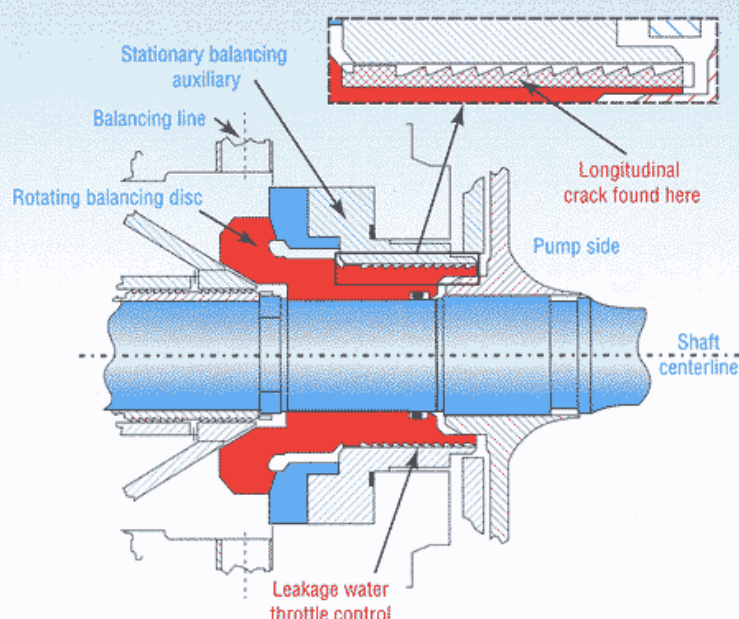
Figure 6. Cutaway view of balancing drum assembly.

The information gathered from the plant provided a clear understanding on the pump operation and internal components and gave an insight into the source of the problem. It was understood that the pump rotor stability and fluid flow balance during operation were primarily maintained by the balancing drum assembly. A cutaway view of a balancing drum assembly (Figure 6) shows the different components responsible for the control process.

The crack in the balancing disc resulted in the loss of throttle con-

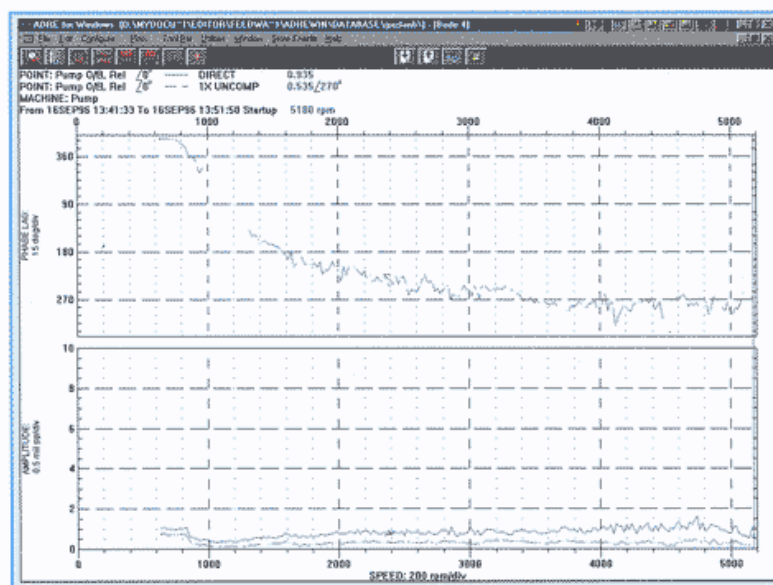
The machine behavior and vibration signatures observed in the survey conducted after replacement of the pump rotor assembly were normal. The Bode plots on the pump bearings (Figures 7 and 8) obtained during the survey on September 16, 1996, showed the normal pattern and low vibration amplitudes during the startup to load condition. Pump abnormalities seen during loading operations and before the correction were no longer present.

Figure 7. Bode plot of pump outboard bearing after replacement of pump rotor assembly.

Upon completing repairs to the pump, the pump was restarted on September 16, 1996. The Bode plot shown in Figure 7 indicates satisfactory operational vibration levels. It further indicates the absence of a balance resonance at 3790 rpm. ☺

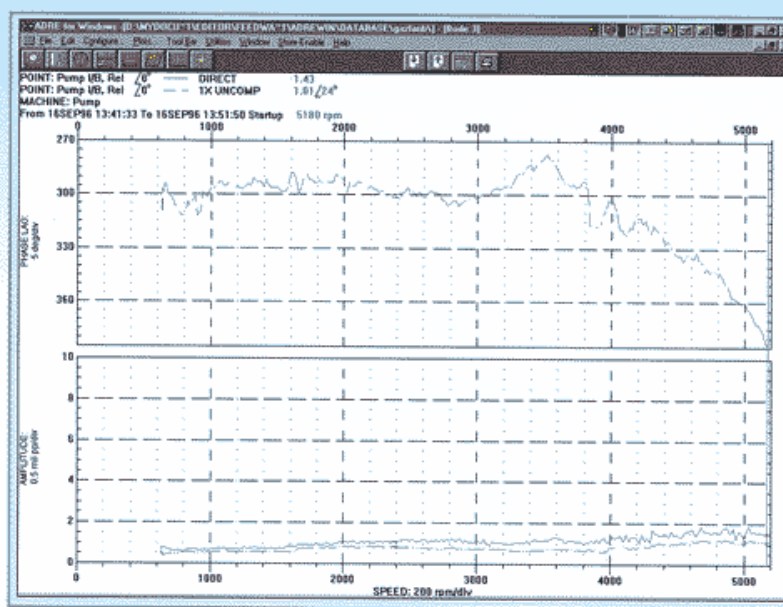
Figure 8. Bode plot of pump inboard bearing after replacement of pump rotor assembly.
